# #18-NA-346: Vehicle Will Not Start and/or Service Electronic Steering Column Lock System Message Displayed on Driver Information Center (DIC) - (Nov 14, 2018)

**Subject: Vehicle Will Not Start and/or Service Electronic Steering Column Lock System Message Displayed on Driver Information Center (DIC)**

Brand:	Model:	Model Year:		Breakpoint:		Engine:	Transmission:
		from	to	from	to		
Chevrolet	Corvette	2005	2005				Equipped with 6 Speed Manual Transmission (RPO MM6)

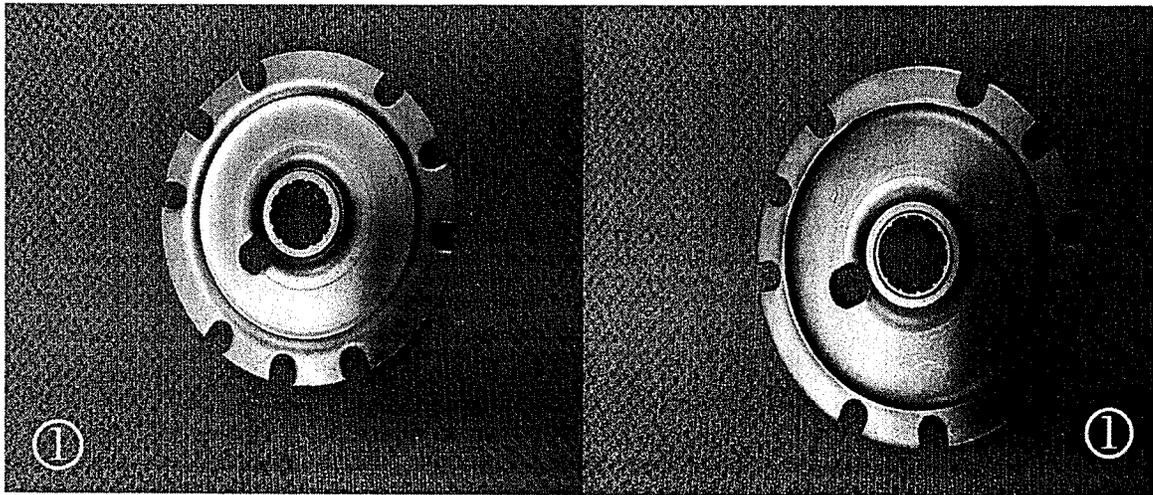
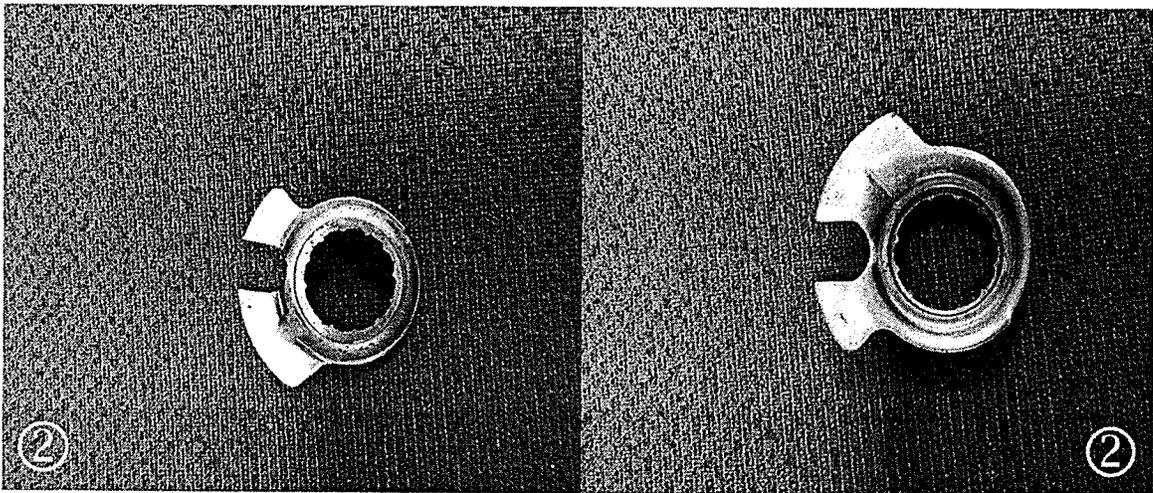
<b>Involved Region or Country</b>	North America and N.A. Export Regions
<b>Condition</b>	Some customers may comment on the vehicle not starting and/or a Service Electronic Steering Column Lock System message being displayed on the Driver Information Center (DIC). <b>Note:</b> The steering wheel may not turn when this condition occurs.
<b>Cause</b>	This condition may be caused by the electronic steering column module failing to send the correct signal to the BCM.
<b>Correction</b>

Replace the steering column lock plate (1) with the new plate (2), and update the BCM with the new utility file.
